Injury Potential Testing of Suited Occupants During Dynamic Spacecraft Flight Phases

Shane M. McFarland¹

MEI Technologies/NASA-JSC, Houston, Texas, 77058

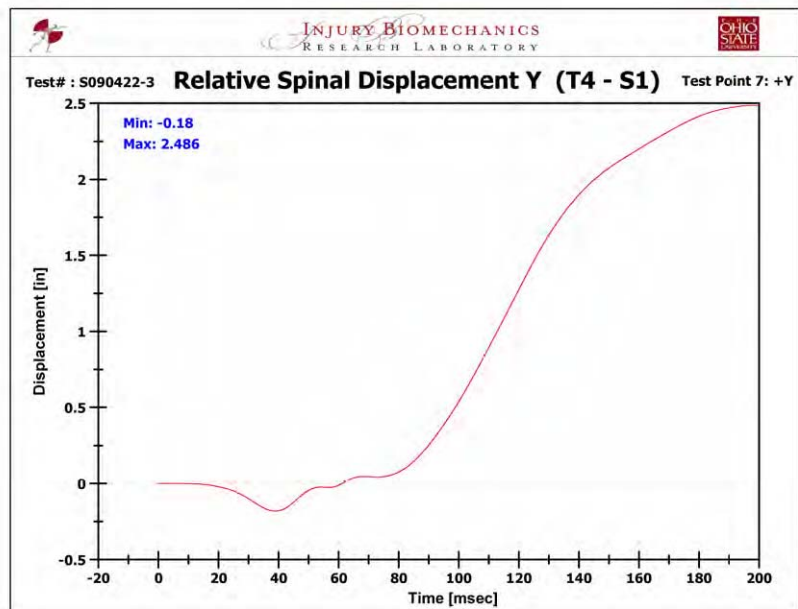
Figure 22: Test Point 7 (Subject F) Spinal Displacement

- The peak acceleration for the spine was 41 g in the z-direction at the T-6 vertebra. The z-axis acceleration for T S-1 was similar at 28 g.
- The spinal accelerations were also similar to what was recorded by subject C in phase I testing.
- This acceleration led to a spinal compression of only .20", Figure 22. The compression cannot be calculated accurately beyond this time due to mathematical error introduced when integrating accelerometers into displacements.

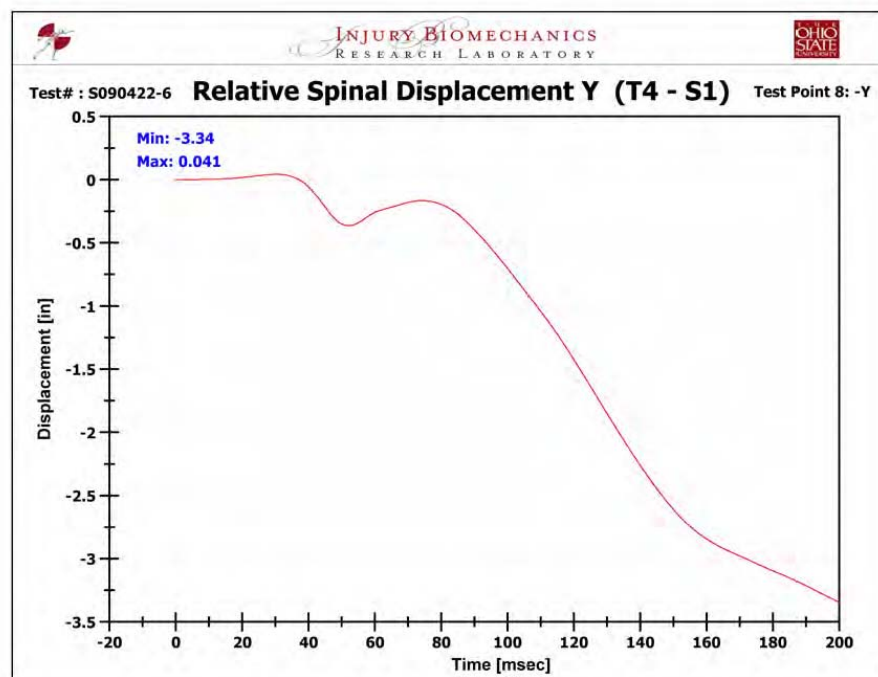
Figure 24: Test Point 8 (Subject F) Spinal Displacement

- The x-axis acceleration of T6 was similar in the range of 17 g.
- The compression of the sternum in relation to T6 in the x-axis direction was calculated using the motion blocks, Figure 24. The maximum value recorded during the event is approximately 1.26", a value below the injury threshold for the thorax used in car safety testing. In fact, it is less than the 1.57" of compression recorded by subject A even with the umbilical connector in addition to the harness.
